Navajo Abandoned Uranium Mine

Site Screen Report

Ada and Nordell AUM Site

January 2011

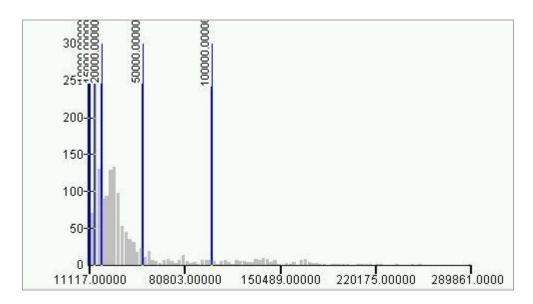
Distribution Chart and Statistics:

The following chart and statistics were generated by ESRI ArcGIS 9.3.1, and show the general distribution of the site gamma radiation measurements. The horizontal X axis represents the gamma radiation reading levels in cpm (lowest levels to the left). The vertical Y axis represents the frequency of each gamma radiation level.

Count:
 1515

Minimum:
 11117,00000

Maximum:
 289861,00000

Mean:
 40586,90429

Median:
 26686,00000

Standard Deviation:
 40649,04911

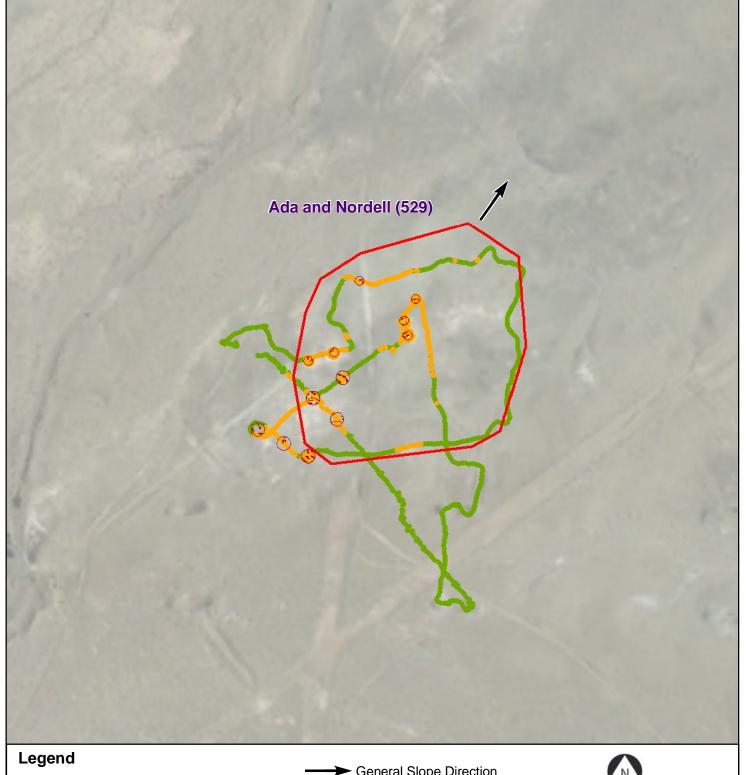
Figure 1 - Gamma Radiation Measurements, Above Two Times Background
Ada and Nordell (529)
Coconino County, Arizona

A total of 1,515 gamma radiation measurements were collected from the mine site, ranging from 11,117 cpm to 289,861 cpm. The measurements collected at the waste piles were found at maximum levels ranging from approximately 150,000 cpm to 250,000 cpm. The measurements are represented in Figures 1 and 2.

Gamma survey conducted 11/2010 Measured as counts per minute (cpm)

Average background 16,540 cpm

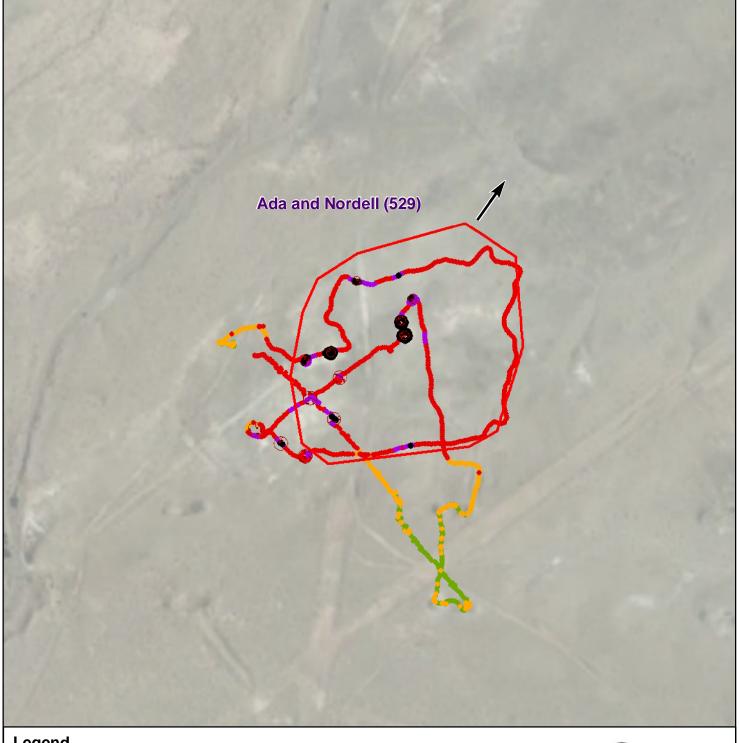
Figure 2 - Gamma Radiation Measurements Ada and Nordell (529) Coconino County, Arizona

Gamma survey conducted 11/2010 Measured as counts per minute (cpm)

Average background 16,540 cpm
